Testing and Evaluation of the W-Beam Transition (On Steel Posts With Timber Blockouts) to the Vertical Flared Back Concrete Bridge Parapet

PUBLICATION NO. FHWA-RD-96-200

NOVEMBER 1997

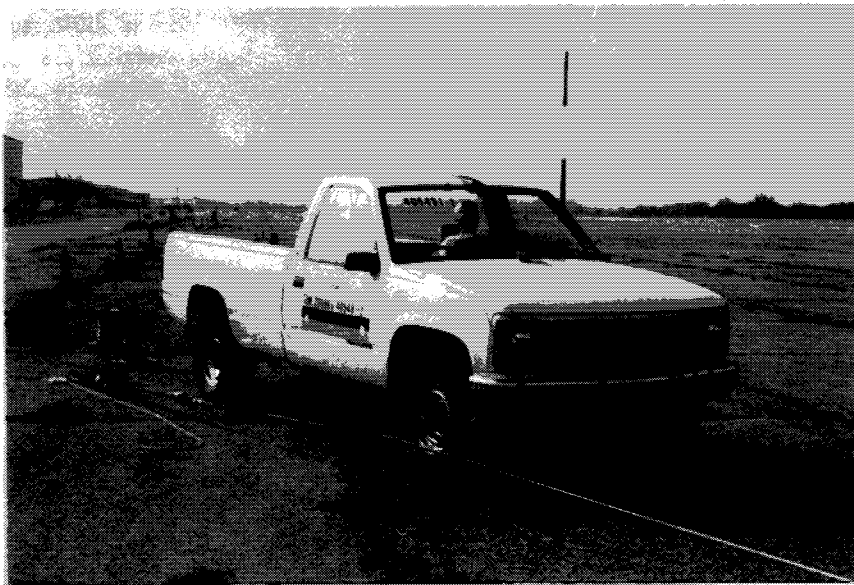
Figure 6. Vehicle before test 405491-2.

A 1989 GMC 2500 pickup truck, shown in figures 5 and 6, was used for the crash test. Test inertia weight of the vehicle was 2000 kg, and its gross static weight was 2075 kg. The height to the lower edge of the vehicle bumper was 455 mm and it was 685 mm to the upper edge of the bumper. Additional dimensions and information on the vehicle are given in figure 7. The vehicle was directed into the installation using the cable reverse tow and guidance system, and was released to be free-wheeling and unrestrained just prior to impact.

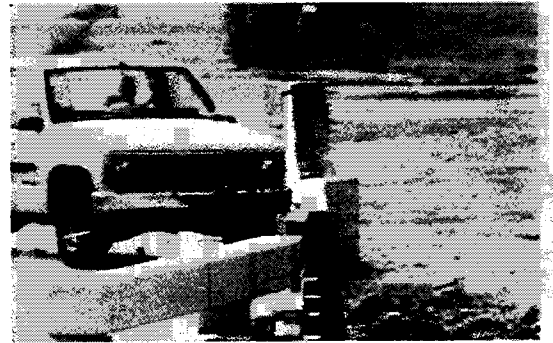
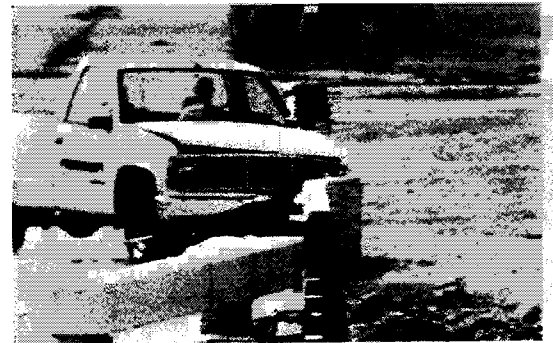
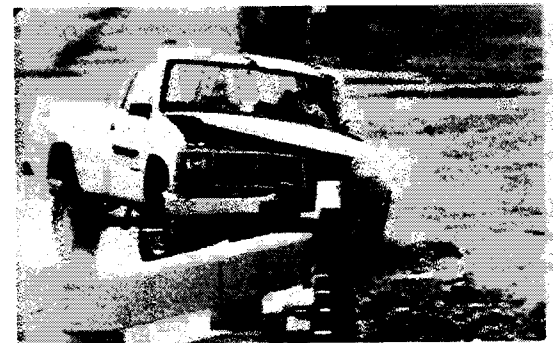
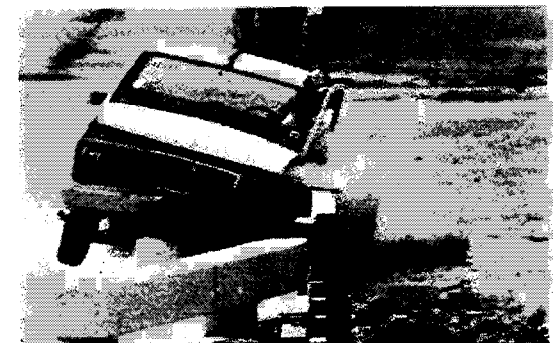
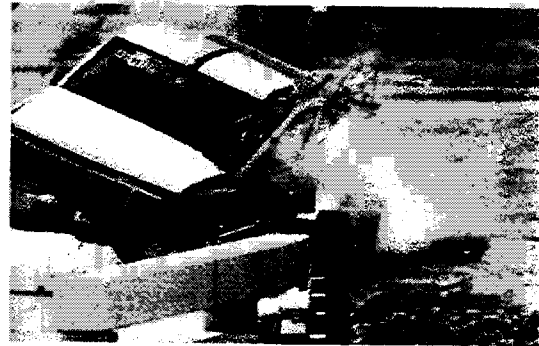
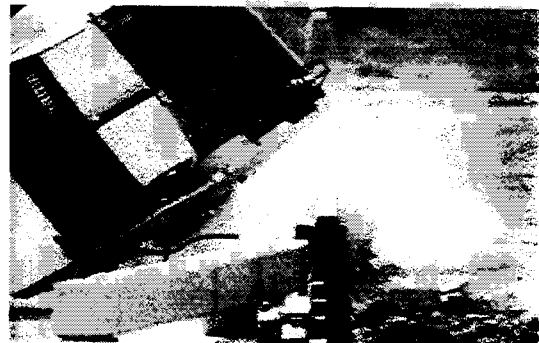
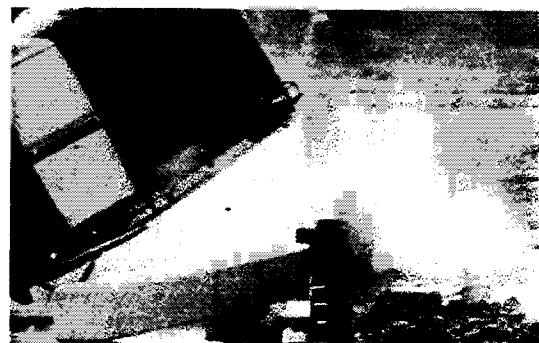
Figure 8. Sequential photographs for test 405491-2 (overhead and frontal views).

The test vehicle, traveling at a speed and angle of 99.8 km/h and 25.3 degrees, impacted the transition section 150 mm upstream of post 4, which was determined to be the Critical Impact Point (CIP). Shortly after impact, movement was noted at posts 4, 3, and 2, respectively. At 0.022 s, the front of the vehicle made contact with post 3 and, at 0.024 s, post 1 began to move. The front of the vehicle made contact with post 2 at 0.039 s and with post 1 at 0.053 s. At 0.066 s, the front of the vehicle impacted the end of the flared back concrete bridge parapet. The vehicle began to redirect at 0.068 s and the bridge parapet began to move at 0.077 s. At 0.194 s, the vehicle became parallel with the transition, traveling at a speed of 72.4 km/h. The rear of the vehicle impacted the W-beam rail element at 0.245 s and the concrete parapet at 0.272 s. At 0.289 s, the rear bumper caught on the bridge parapet. The vehicle lost contact with the bridge parapet at 0.573 s, traveling at an exit speed and angle of 66.2 km/h and 18.5 degrees. As the vehicle exited the test installation, it yawed clockwise and rolled counterclockwise. The vehicle rolled 360 degrees and subsequently came to rest facing the impact point 47.5 m down and 11.9 m forward. Sequential photographs of the test period are shown in figures 8 and 9.

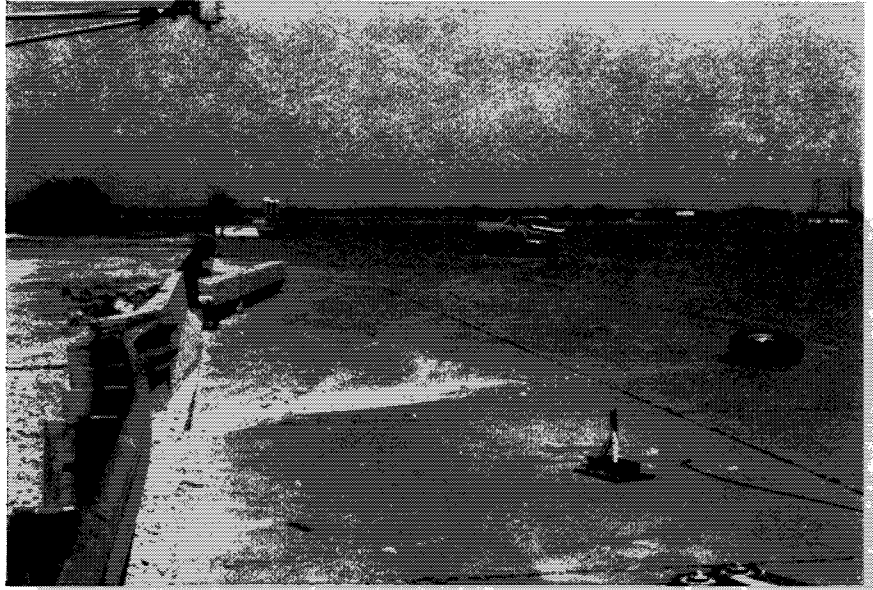
Figure 10. After impact trajectory for test 405491-2.

Damage to the installation is shown in figures 10 through 13. Posts 6 through 1 were pushed back 10 mm, 35 mm, 85 mm, 125 mm, 160 mm, and 140 mm, respectively. The timber blockouts were damaged as shown in figure 12. There were tire marks on the face of the W-beam rail element and on the concrete parapet (see figure 13). There were shear cracks in the parapet and the parapet was pushed away from the bridge deck 35 mm, as can be seen in figure 13. Total length of contact of the vehicle with the installation was 4.1 m.

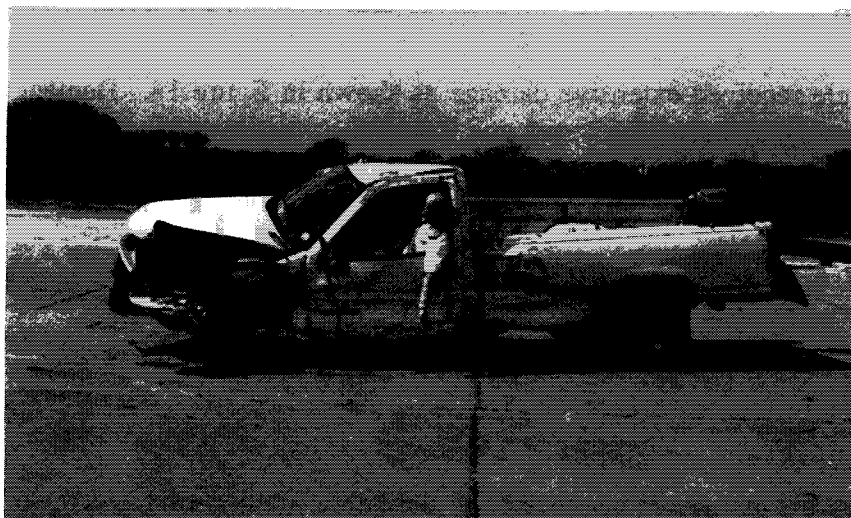
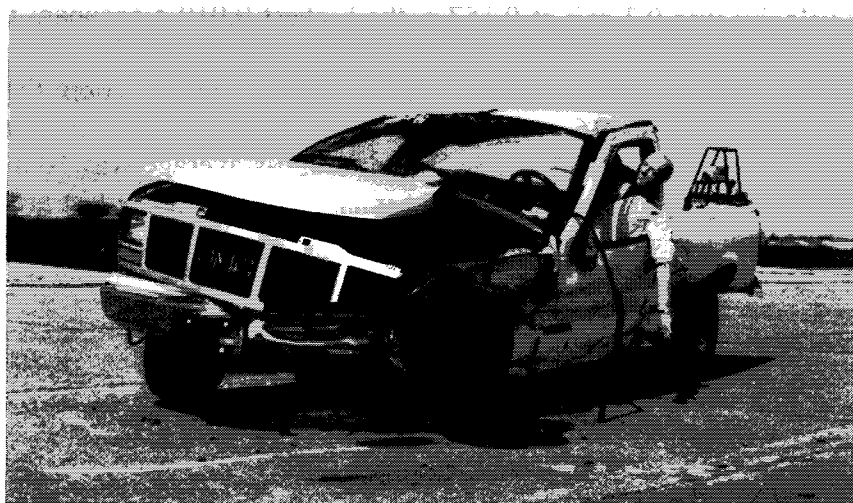
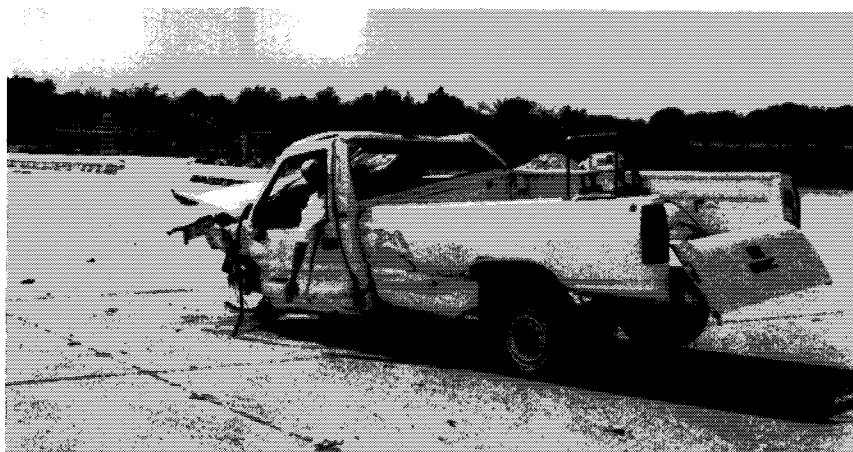
Figure 14. Vehicle after test 405491-2.

The vehicle received extensive damage as shown in figure 14. Damage to the left front wheel assembly included the upper and lower A-arms, tie rods, stabilizer bar, pitman arm, and steering box, and the tire, wheel and spindle were torn from the vehicle. The frame was bent and the floorpan was buckled. The front bumper, hood, grill, fan, radiator, left front quarter panel, left door, left side of the bed, and left tire and rim were also damaged. The roof, windshield, both door windows, and the right side of the vehicle were damaged during the rollover.
